DEPARTMENT OF TRANSPORTATION

Contract #: 04-0120F4Cty: SF/ALA Rte: 80 PM: 13.2/13.9File #: 69.28**WELDING INSPECTION REPORT****Resident Engineer:**Siegenthaler, Peter**Address:** 333 Burma Road**City:** Oakland, CA 94607**Report No:** WIR-021264**Date Inspected:** 03-Jul-2010**Project Name:** SAS Superstructure**OSM Arrival Time:** 700**Prime Contractor:** American Bridge/Fluor Enterprises, a JV**OSM Departure Time:** 1900**Contractor:** Zhenhua Port Machinery Company, Ltd (ZPMC), Changxing Island **Location:** Shanghai, China

Bridge No: 34-0006**Component:** OBG Segment Assembly**Summary of Items Observed:**

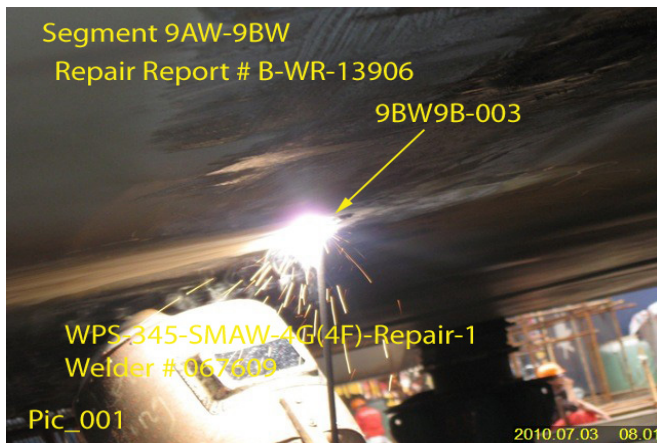
Shielded Metal Arc Welding (SMAW) in the 4G position of Bottom Panel repaired area as per repair report # B-WR-13906, weld joint OBW9B-003. The welder is identified as 067609. ZPMC Quality Control (QC) is identified as Shi Lei. The welding variables recorded by QC appeared to comply with WPS-345-SMAW-4G(4F)-Repair-1. See attached photograph Pic_001

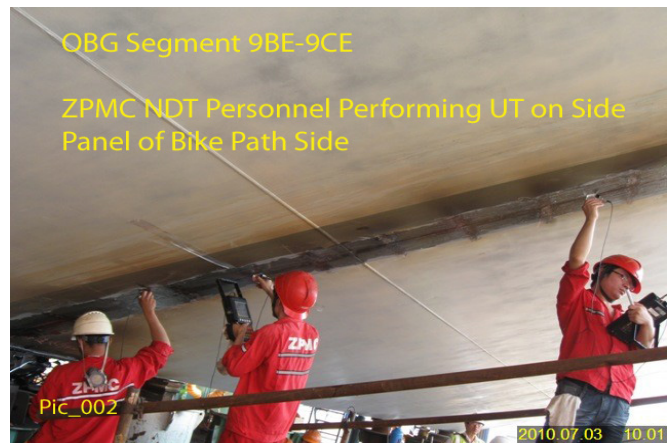
During in process visual inspection of 9BE-9CE, This QA Inspector observed ZPMC NDT personnel performing Ultrasonic Testing (UT) on Side Panel of Bike Path side. See attached photograph Pic_002
